Maryland Inventory of Historic Properties Historic Bridge Inventory Maryland State Highway Administration Maryland Historical Trust

MHT Number SM-519

Name and SHA No. 18010 over Church Creek

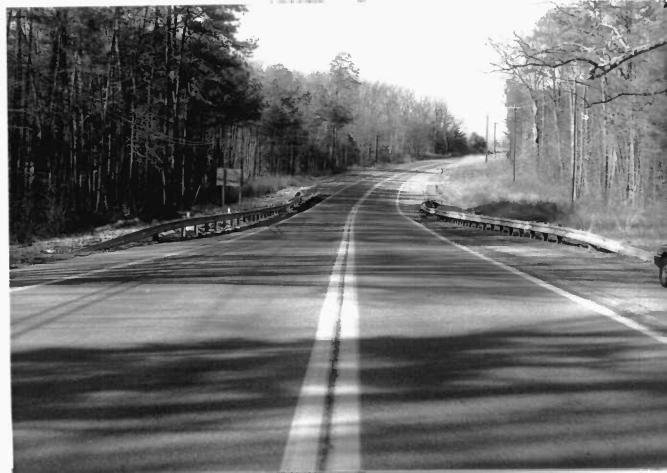
SM-519 ST MARYS COUNTY D. BHOUMICE 2-1-95 MARYLAND SHPO MD 5 OVER CHURCH CREEK LOOKING NORTH ON MO 5 (BRIDGE 13010)

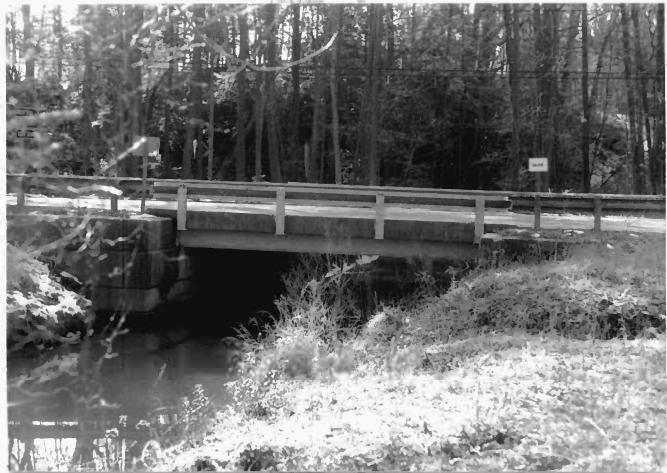
200 4 5/11-5/9 ST MARYS COUNTY D. BHAUMIE 2-1-95 MARY CAND SHPO MD 5 OVER CHURCH CREEK LOOKING WEST (UPSTREAM FACE) (BRIDGE 15010)

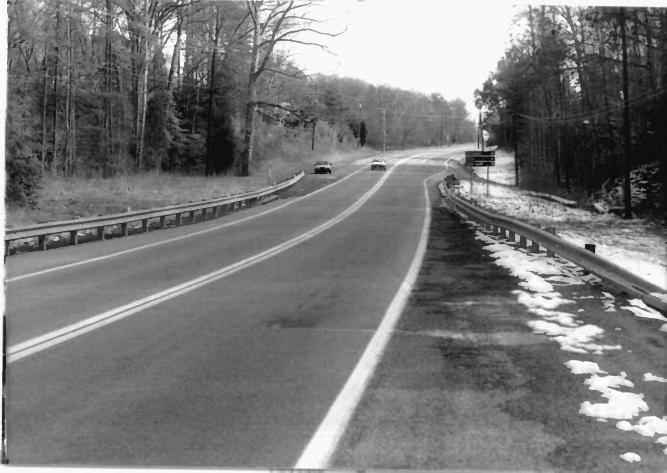
3 OF 4 SM-519 ST MARYS COUNTY D. BHOUMK 2-1-95 4-3 MARYLAND SHPO MDS OVER CHURCH CREER LODICING SOUTH ON MD 5 (BRIDGE 18010)

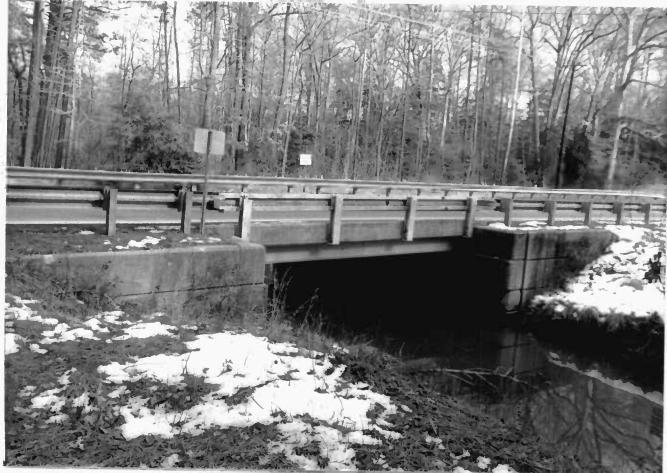
4 OF 4 5111-519 ST MARYS COUNTY D. BHAUMIK 2-1-95 SHA MARYLAND SHPO MD 5 OVER CHURCH CREEK COOKING EAST COUNSTREAM FACE) (BRIDGE 18010)
